# Manhole Inspection Summary

Manhole # S45U\_\_024MH

Insp Date: **3/6/08 10:03 AM**

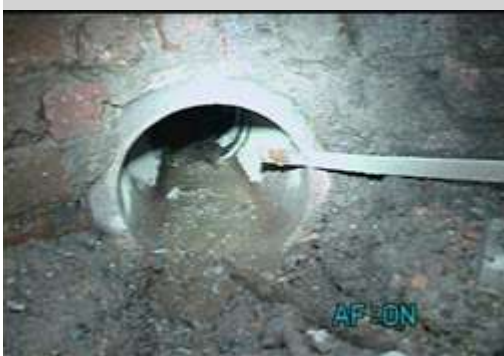
Miscellaneous

debris in pipe

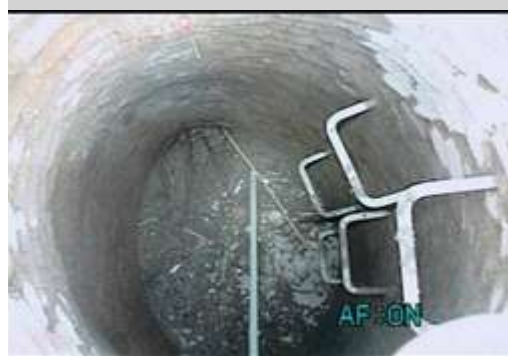
Defect 1

**Corbel** Material: **Brick** ☐ Parged Type: **Concentric/Eccentric**  
Condition: ☒ Sound ☐ Cracked ☐ Root Intrusion ☐ Loose Brick ☐ Deteriorated  
Infiltration: ☐ None ☐ Joint ☐ Cracks ☐ Mortar ☐ Roots ☒ Wall

**Channel** Material: **Brick** ☐ Parged  
Channel Exposure: **Fully Open** Junc Dist: **0** nearest .5 ft. Azimuth: **0**  
Condition: ☐ Sound ☐ Cracked ☐ Root Intrusion ☐ Deteriorated ☐ Leaks ☒ Debris

debris in channel; infiltration of corbel wall

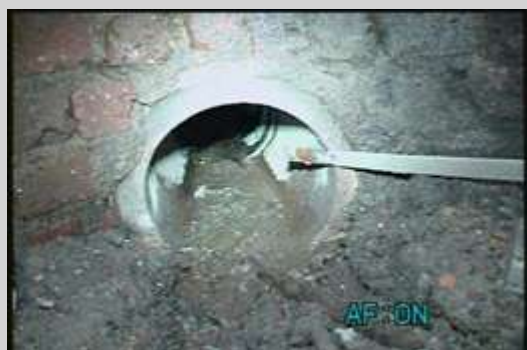
12 O'Clock Outflow

8 in. Circular Gravity Sewer  
Pipe Out @ 12 O'Clock

Deposits: ☐ None ☐ Mud ☐ Sludge ☒ **Debris** ☐ Grease

Silt Depth: **2** (in.) Deposits Extent: **Light**
